# A pump is only as good as its shaft seal

The Risks of Buying and Using Non-Original, Non-Approved Parts

Case Story

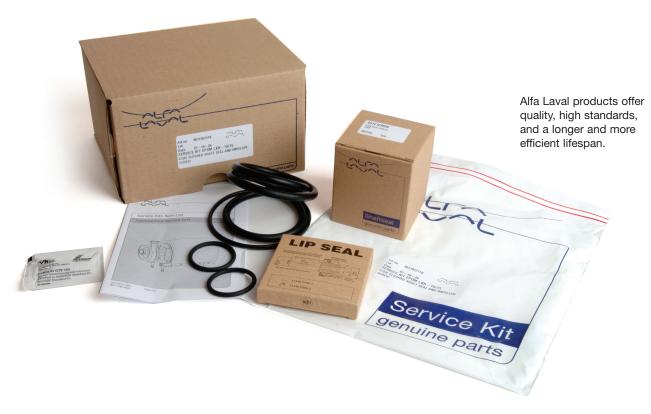
Packaging doesn't guarantee a quality product.
